DISK RESIDUAL LIFE STUDIES

PART 1: F100 1ST-STAGE TURBINE DISK (IN100)

J. S. Cargill, J. K. Malpani, Y. W. Cheng

Pratt & Whitney Aircraft Group
Government Products Division
West Palm Beach, Florida 33402

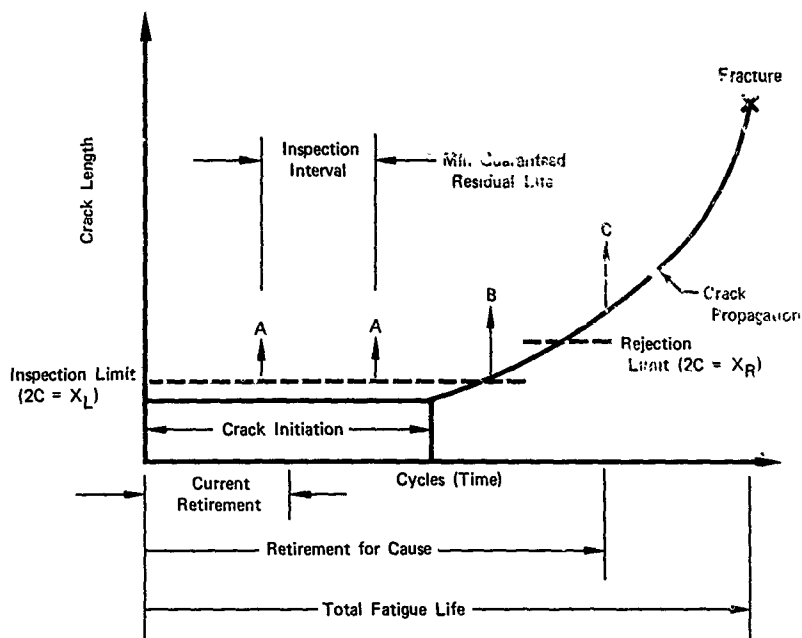
- A - AE, EC, and FP Produce No Indications. Component Could Be Reinstalled
- B - AE, EC, and/or FP Produce Indication ($2C = X_i$), but $X_L \leq X_i < X_R$. Component Could Be Reinstalled
- C - AE, EC, and/or FP Produce Indication ($2C = X_{i+1}$), and $X_{i+1} \geq X_R$. Component Is Rejected

Figure 1. Residual Life Prediction as Applied to Retirement-for-Cause

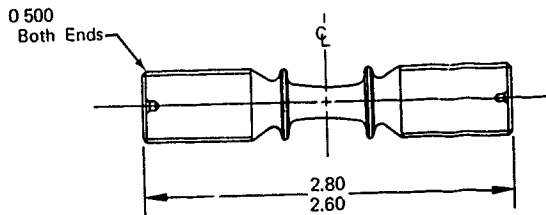
Figure 2. Constant Strain LCF Specimen

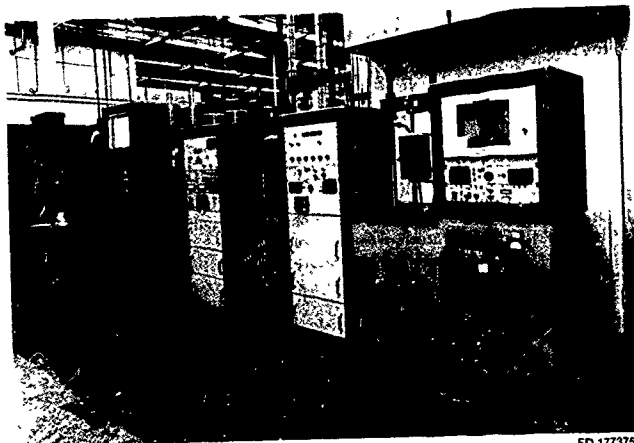
Figure 3. P&WA/GPD Component Life Analysis Group Test Area

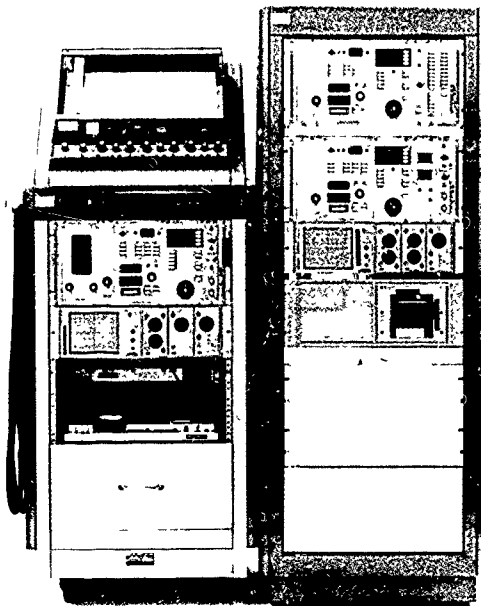
Figure 5. AE Laboratory Apparatus Used for Continuous Inspections During Fatigue Testing

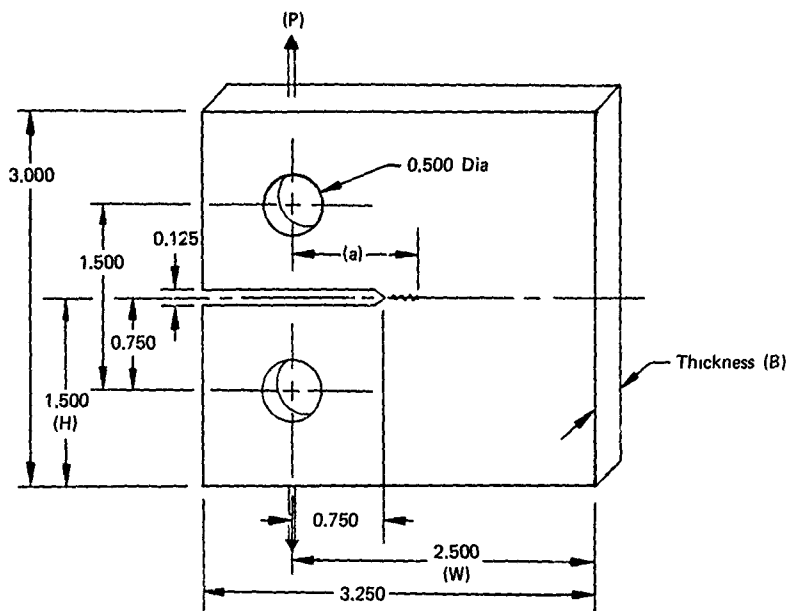
Figure 6 Modified Compact Tension Specimen

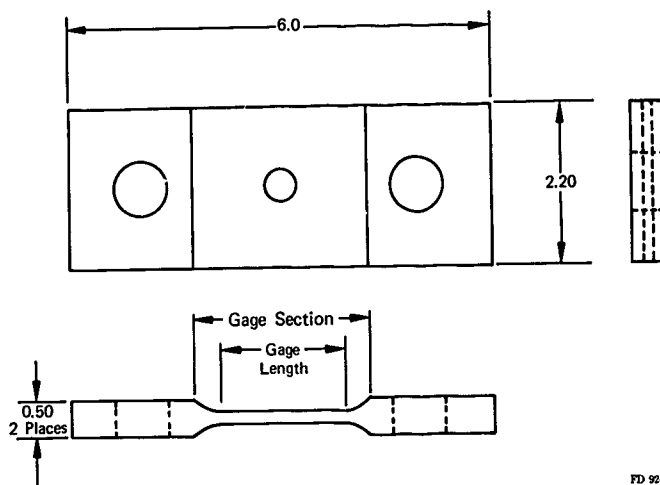
Figure 7. Bolthole LCF Specimen FML 96308A

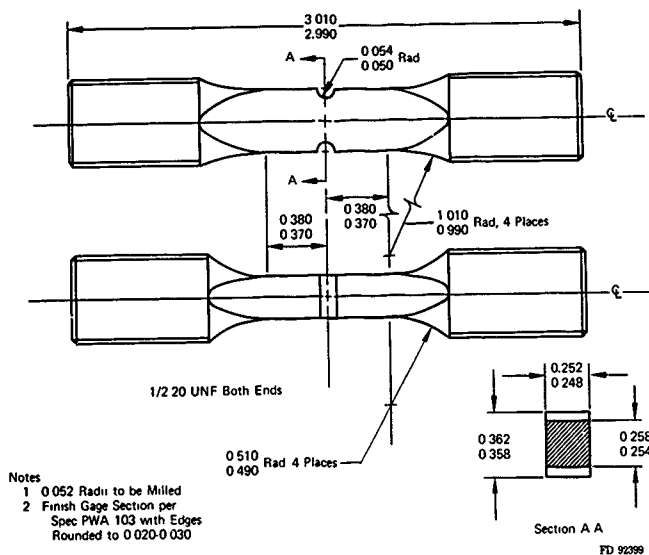
- Notes
- 1 0.052 Radii to be Milled
 - 2 Finish Gage Section per Spec PWA 103 with Edges Rounded to 0.020-0.030

Figure 8. Dovetail Groove LCF Specimen PWA 1073 $K_1 = 2.0$

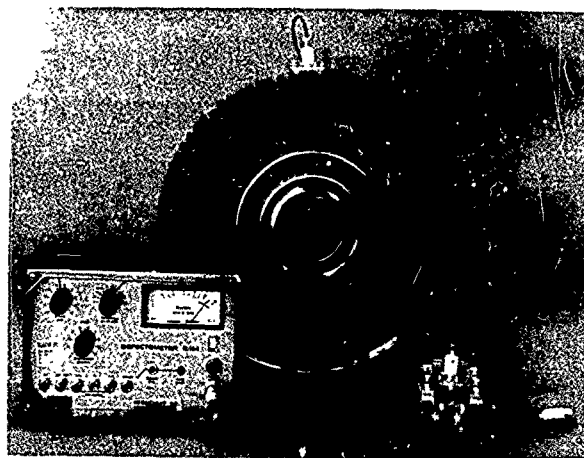
Figure 10. Defectometer Model 2.164 EC Inspection Instrument With Fixtures and Probes

As seen previously in the lower right corner of Figure 10, IN100 dovetail groove simulation specimens were held securely in a plexiglass fixture. Crack indications were produced by passing a probe back and forth along a slot in the fixture which allowed chatter-free contact of the probe with the specimen surface. The probe was typically passed to each end of the specimen slot until edge effects precluded any further inspection

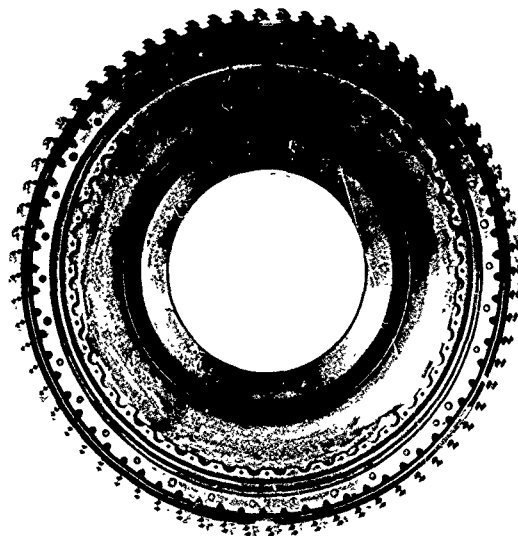
Figure 11. F100 1st-Stage High-Pressure Turbine Disk, Made of GATORIZED® P/M IN100

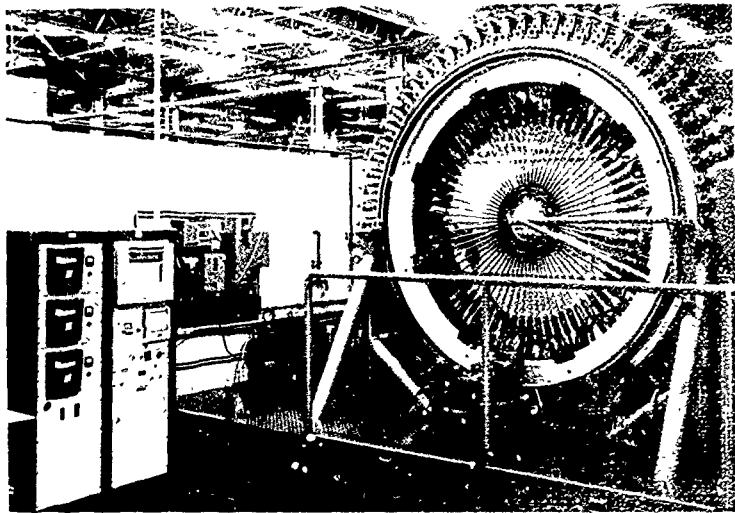
Figure 12. Structural Test Laboratory "Ferris Wheel" Facility

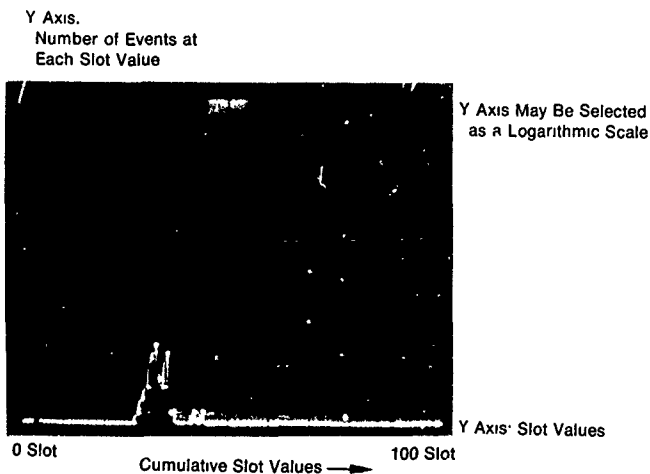
Figure 19 Distribution Analyzer Histogram, Normal Output

Figure 19 is an oscilloscope representation of a typical analyzer output. For example, if the analyzer had been operating in a one-dimensional source-locate mode, the X-axis would represent the distance (divided into 100 increments) between a transducer located at "0" and a second transducer located at "100". The Y-axis output would display the number of AE events whose source locations correspond to each of the 100 distance increments. Events whose sources are outside the boundaries determined by the two transducers are automatically assigned to either slot value 0 or 100.

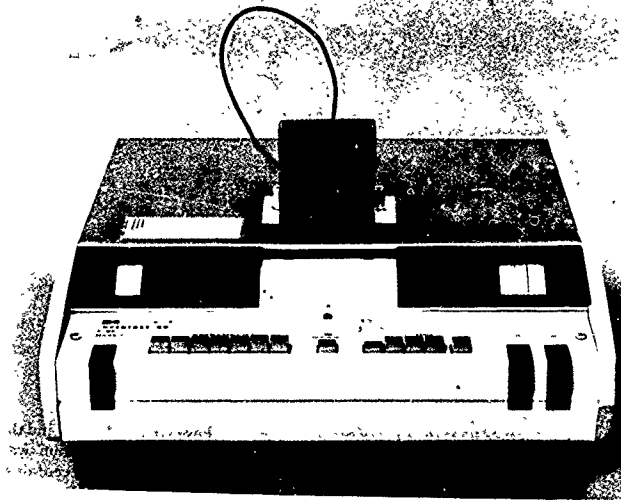
Figure 20. Q-Meter Inspection System for Ferrite Toroids

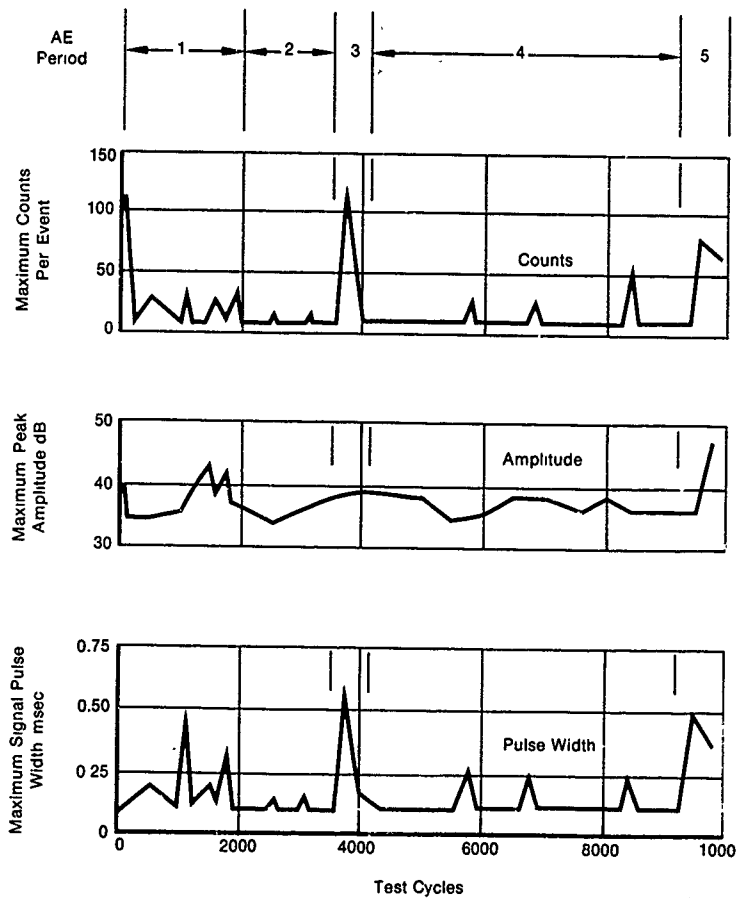
Figure 25. LCF Specimen 217-1

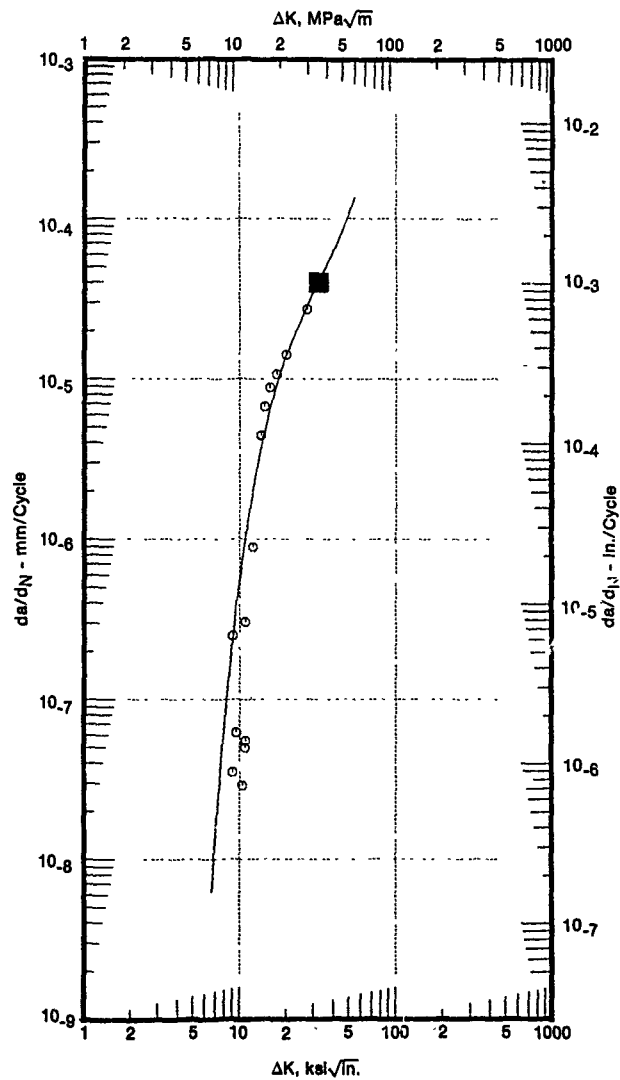
Figure 27. Crack Growth Characteristics of IN100 at 1000°F, $R = 0.1$, 10 cpm

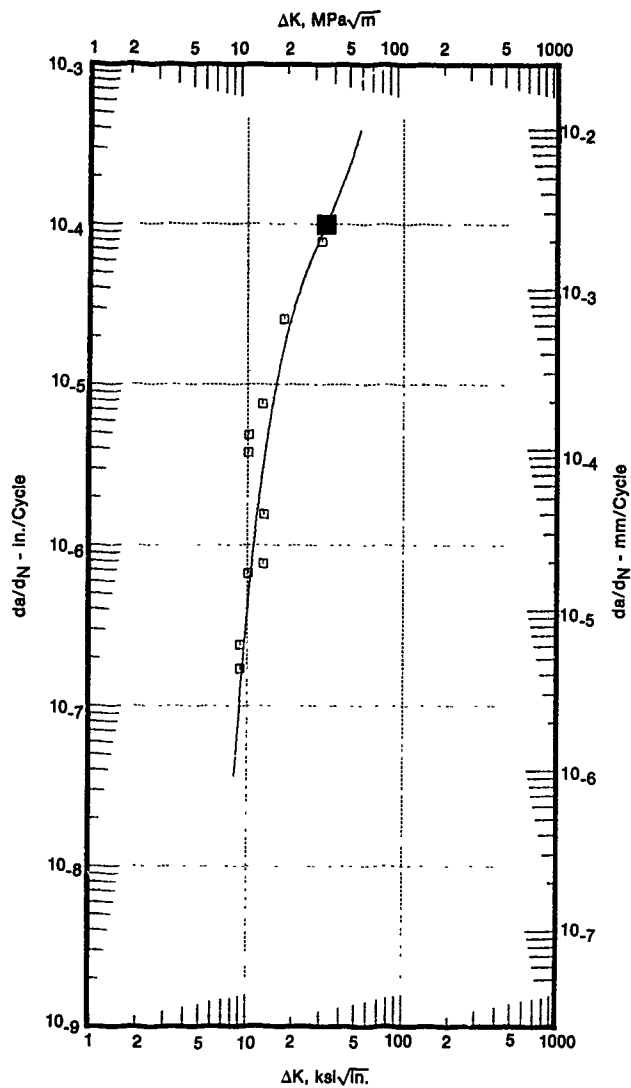
Figure 28. Crack Growth Characteristics of IN100 at 1200°F, $R = 0.1$, 10 cpm

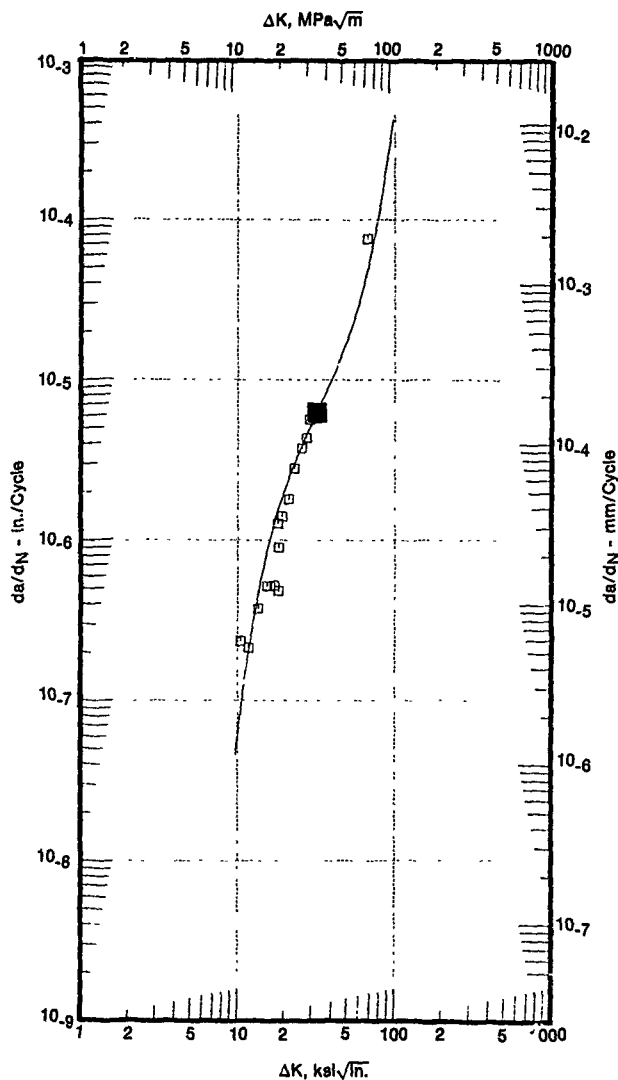
Figure 29. Crack Growth Characteristics of IN100 at Room Temperature, $R = 0.1$, 10 cpm

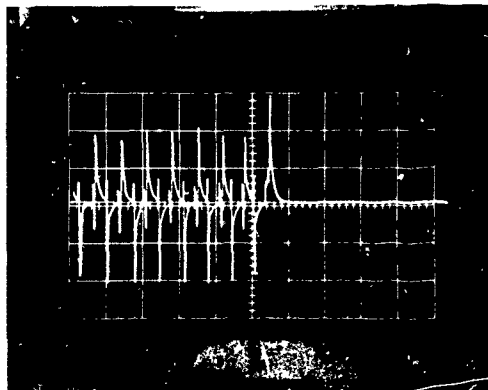
Uncracked Notch: Peaks Are Edge Lift-Off Effect as Probe Is Passed Back and Forth Many Times

Cracked Notch: Short Spikes Between Edge Lift-Off Effects Are the Macrocrack Indications

Figure 31 Dovetail Groove LCF Specimen S/N D-1 EC Defectometer Records

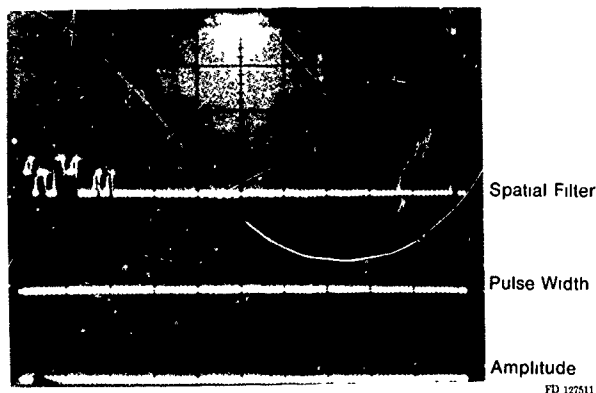
Figure 33 Duetail Groove LCF Specimen S/N D-5 AE Distribution Histogram Records

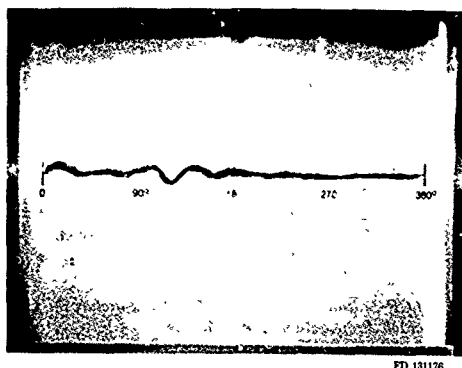
Figure 36. LCF Specimen BR-4, 15,000-cycle Circograph EC Inspection Records

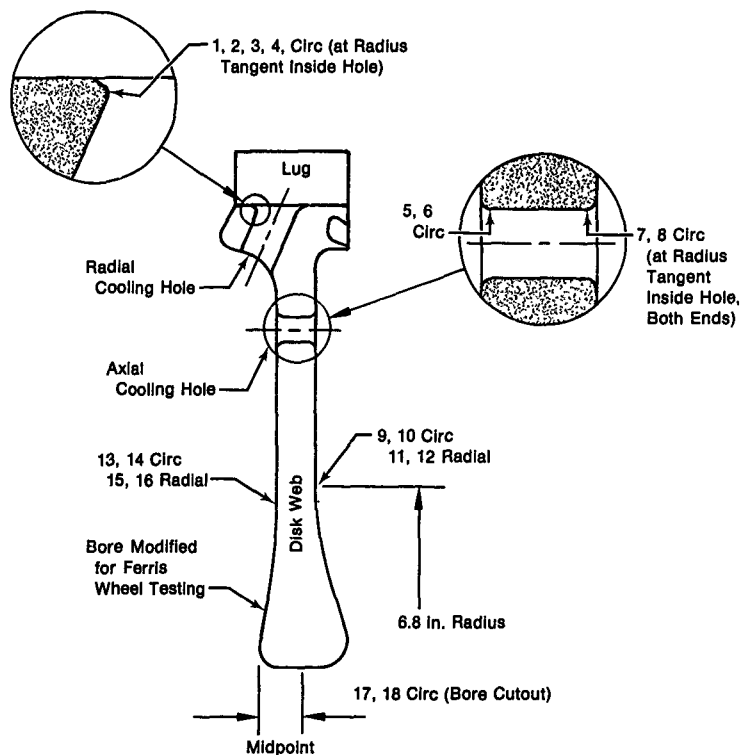
Figure 41. F100 1st-Stage Turbine Disk S/N BDB 257 Strain Gage Locations for Experimental Stress Analysis

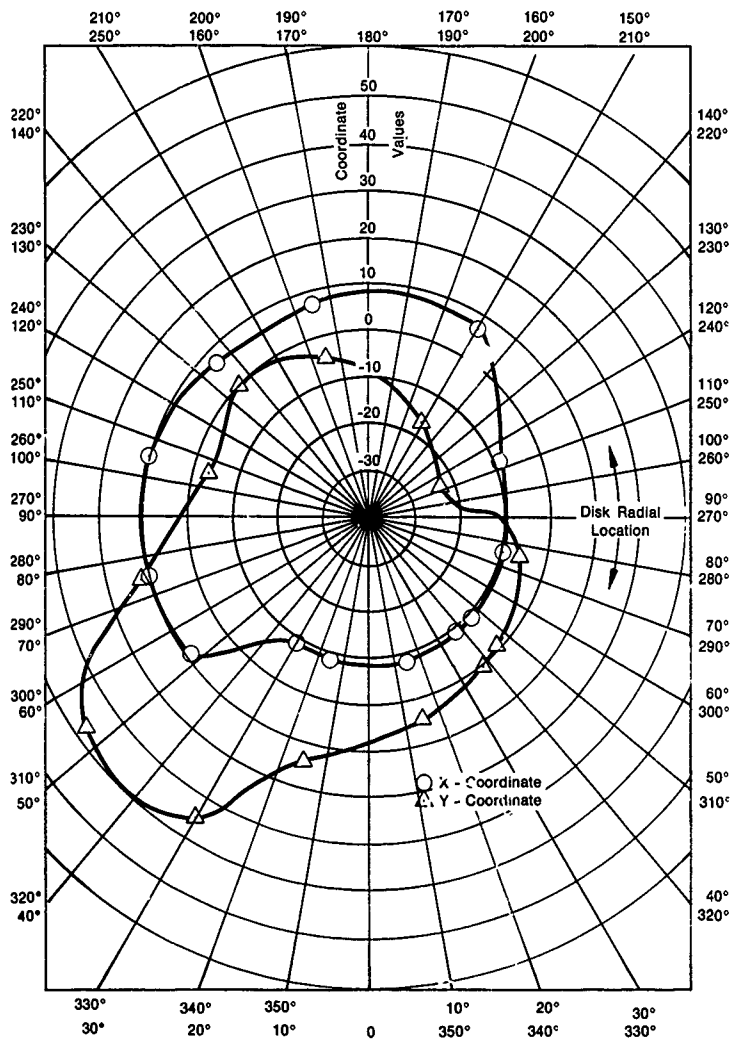
Figure 45 AE Characterization of F100 Balance Weight Snap Ring

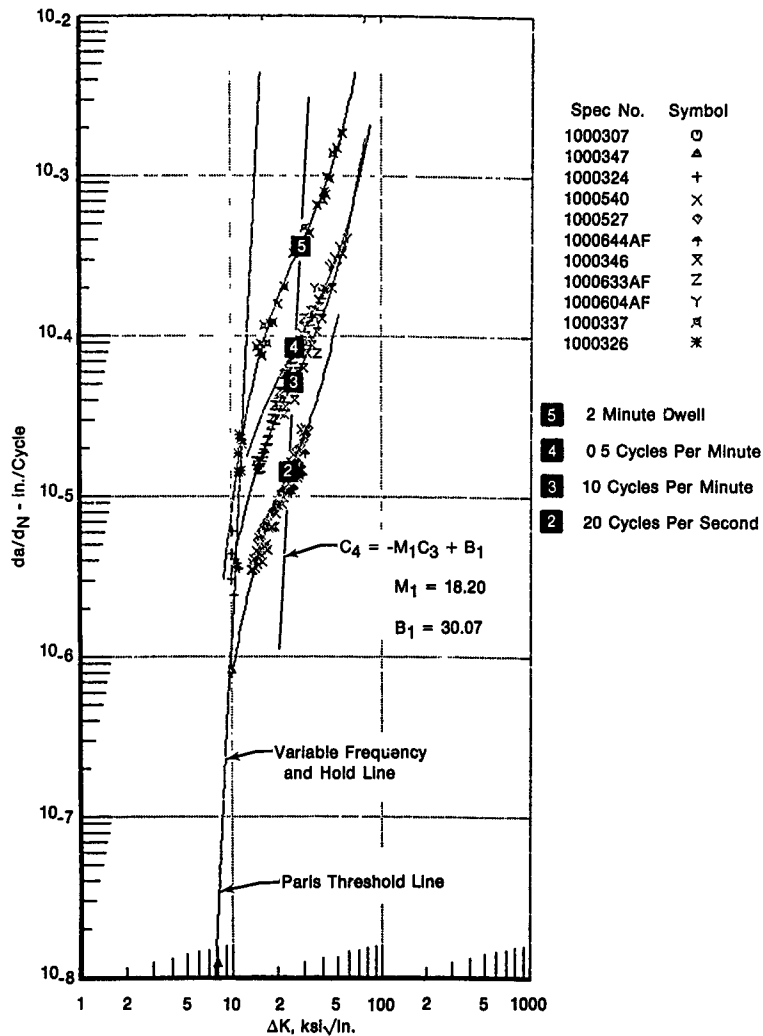
Figure 49. The Effect of Frequency on Crack Growth Rate at 1200°F, $R = 0.1$

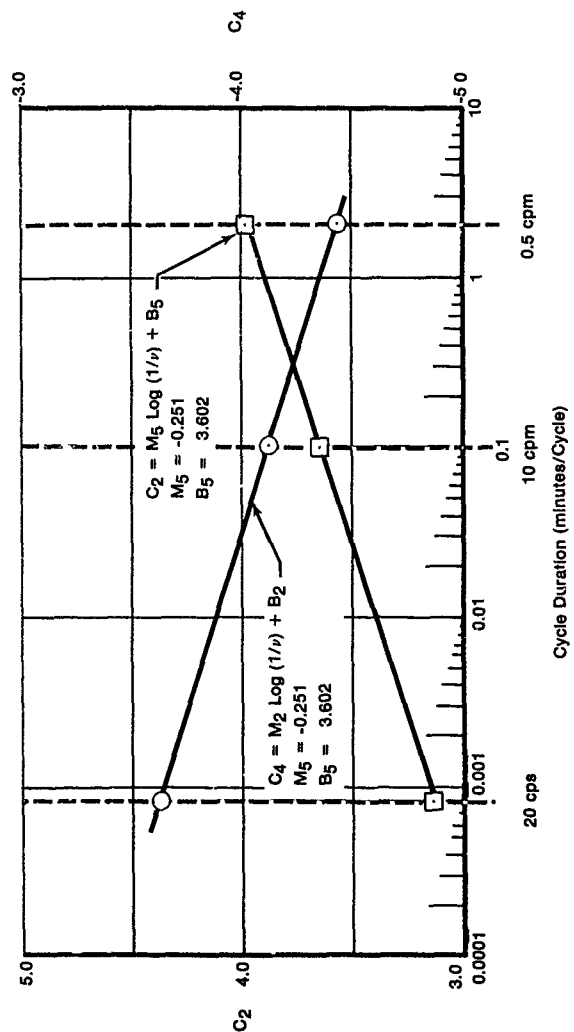
Figure 50. Effect of Frequency on Sinh Model Coefficients C_2 and C_4 at 1200°F , $R = 0.1$

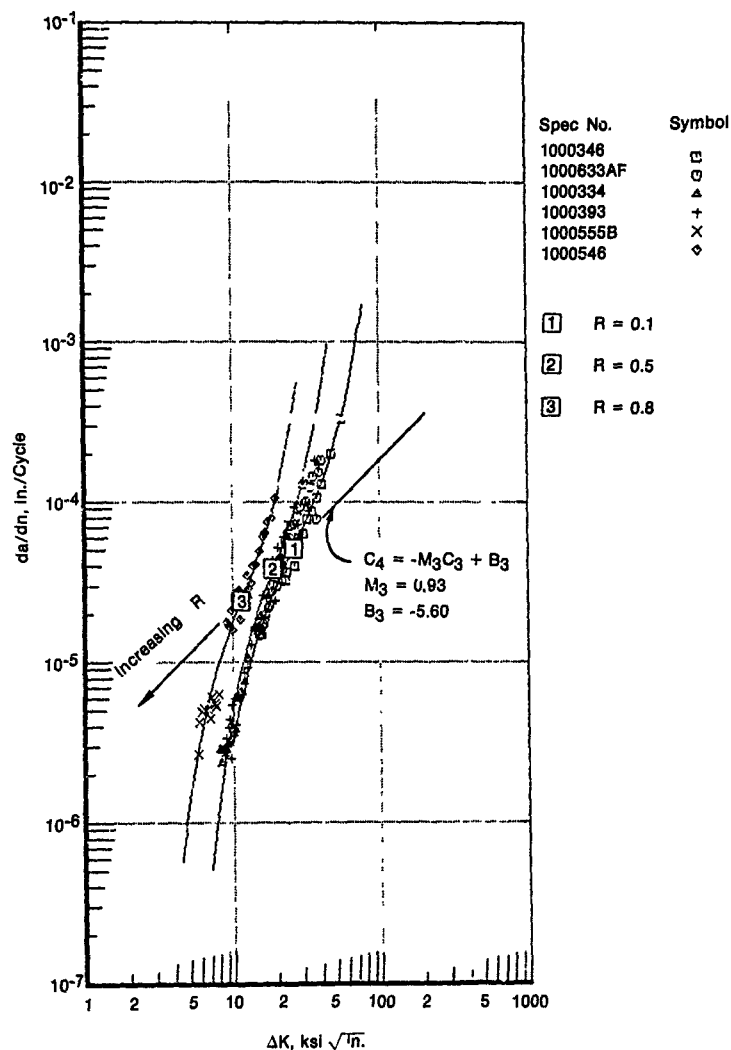
Figure 51. Effect of Stress Ratio on Crack Growth Rate at 1200°F, 10 cpm

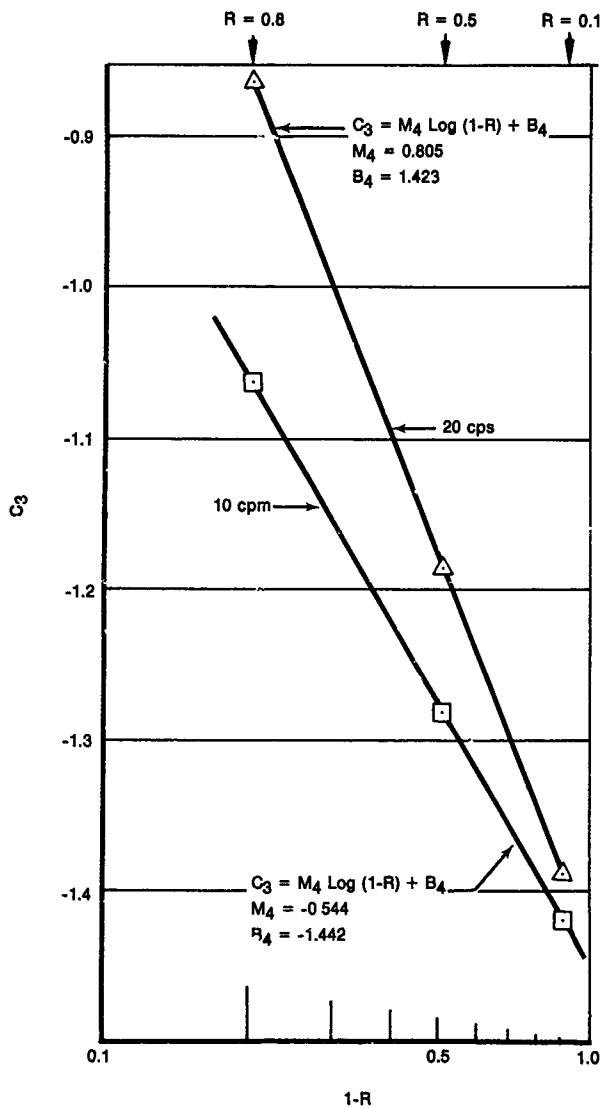
Figure 52. Effect of Stress Ratio, R , on Sinh Model Coefficient, C_3 , at 1200°F

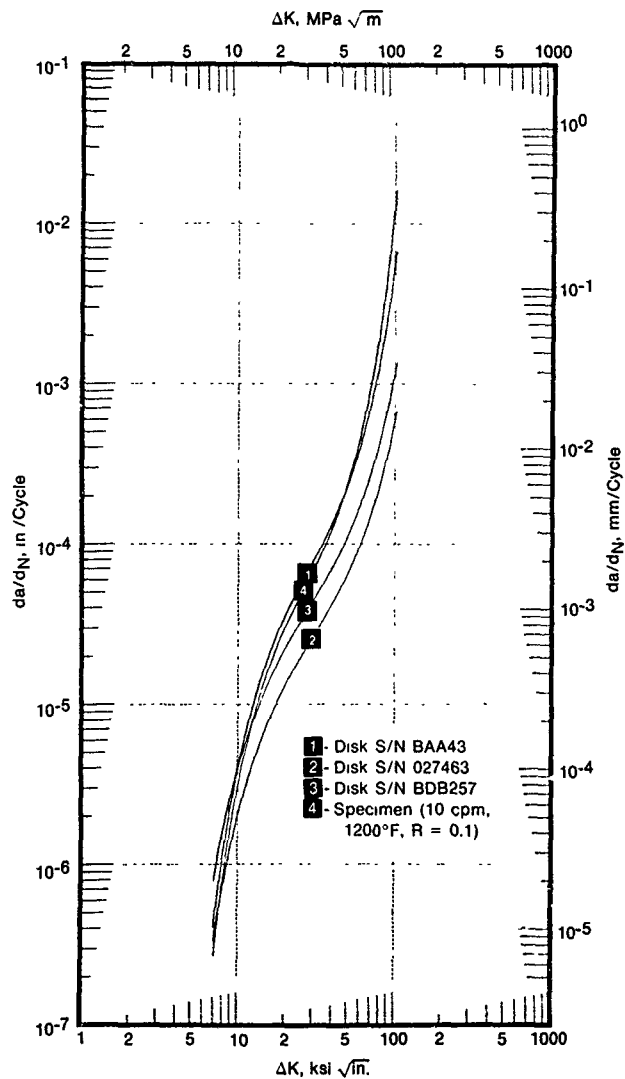
Figure 53 Crack Growth Models for Phase IV Turbine Disk Tests

The da/dN model is shown in Figure 53 as curve No. 3.

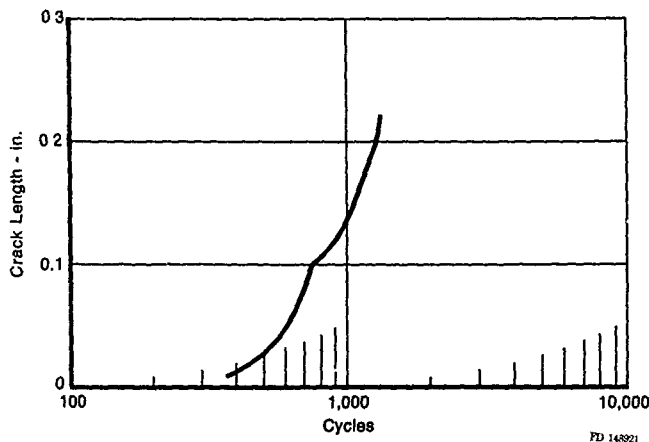
Figure 58 1st-Stage Turbine Disk S/N BDB 257 Radial Cooling Hole Residual Life Prediction

A fracture mechanics residual life analysis was again performed using equation (19) and the stress intensity solution of Figure 48. The resulting a vs N relationship (Figure 58) predicts a residual life of 959 cycles from $a_i = 0.010$ in. Therefore, periodic inspections were performed during the ferris wheel test program in increments of 1000 cycles or less to demonstrate flaw inspectability before disk failure (the basis of Retirement-for-Cause philosophy).

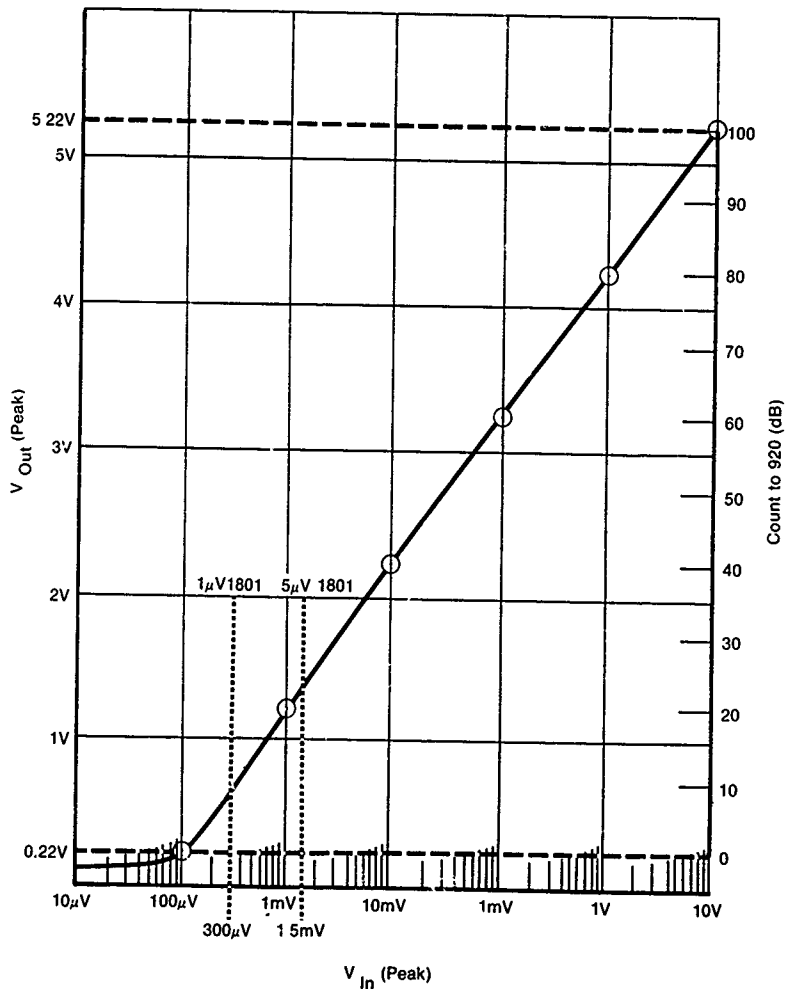
Figure 63. Log Amplification Characteristics of Dunagan/Endevco 920/921 Amplitude Distribution Analyzer
